Influence of fluorine-containing mouthwashes on NiTi Alloy corrosion

Zoran Bobić, Bojan Petrović, Sanja Kojić, Vladimir Terek, Branko Škorić, Lazar Kovačević, Goran Stojanović, Pal Terek

INFLUENCE OF FLUORINE-CONTAING MOUTHWASHES ON NITI ALLOY CORROSION

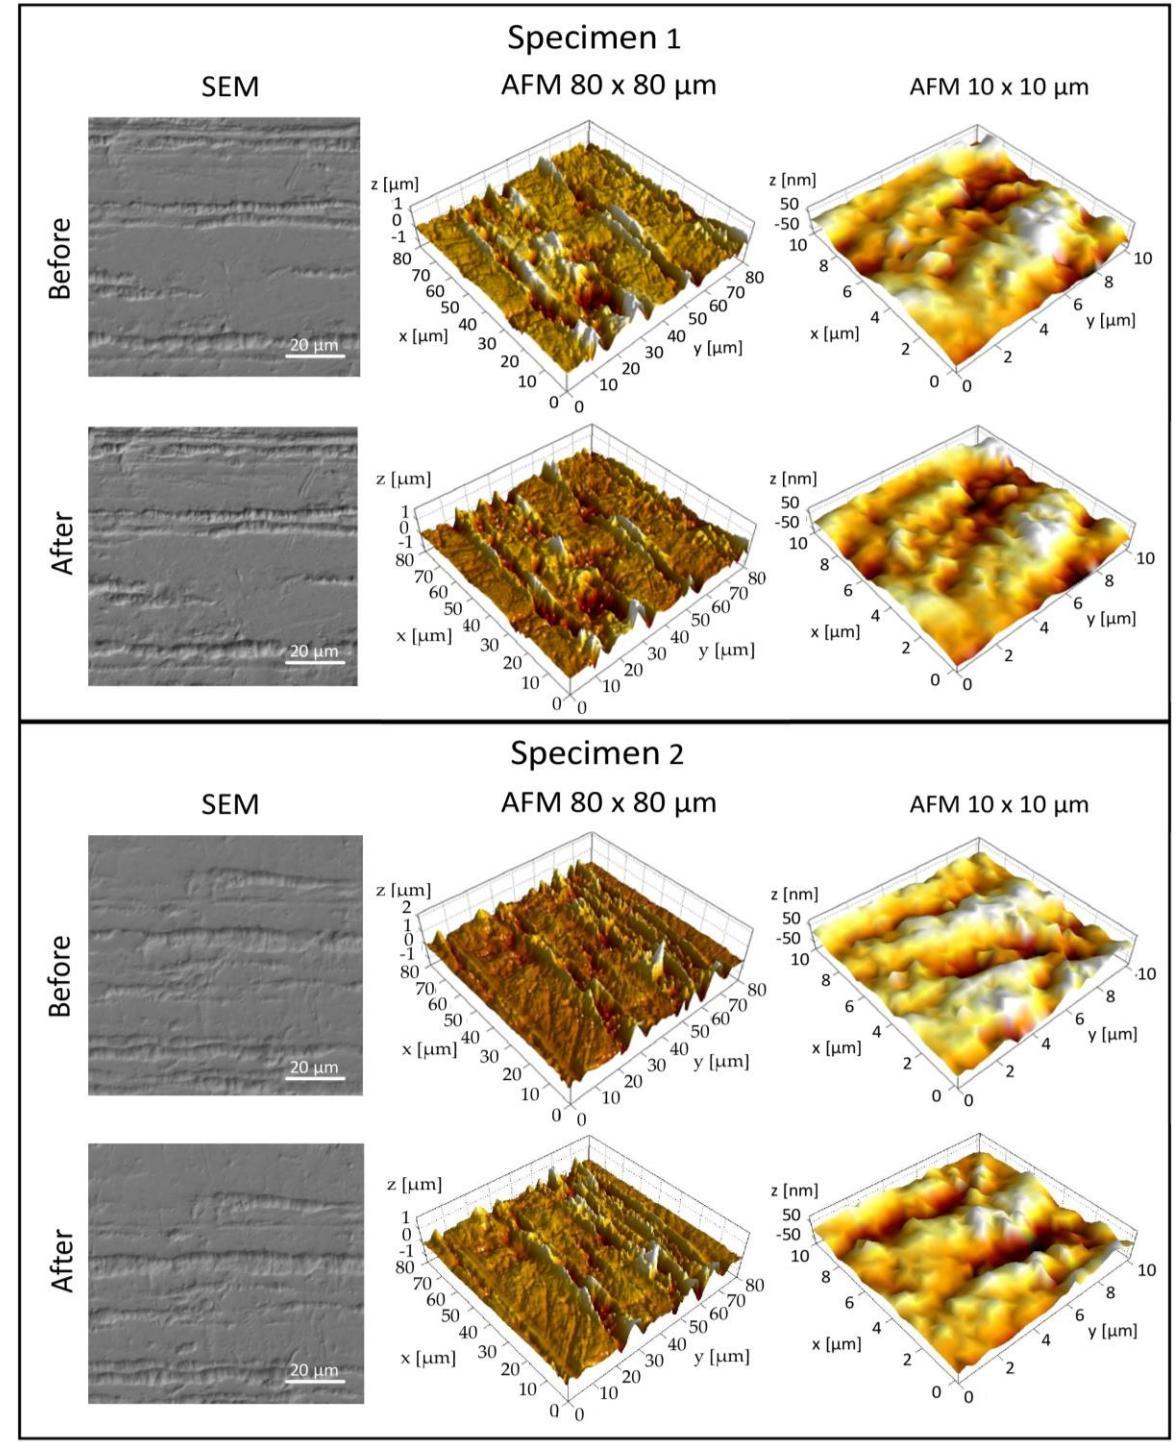
Figure 1. Representative AFM (80 x 80 μ m and 10 x 10 μ m) and SEM(80 x 80 μ m) images for Specimen 1 and 2, before and after corrosion test

Representative SEM and AFM images of specimen surfaces before and after the corrosion tests are given in Figure 1. The initial surfaces of the specimens are characterized by relatively parallel deep grooves. The area between the grooves is much smoother. When comparison is made between the SEM and AFM images of 80 x 80 μ m areas (Figure 1), of surfaces before and after the corrosion tests, differences in topography cannot be noticed. However, when the small areas (10 x 10 μ m) between the grooves of Specimen 2 (Figure 1) are compared, changes in nano-topography induced by corrosion are evident.

Analysis of AFM and SEM images, surface roughness parameters, and chemical composition of Specimen 1, before and after the corrosion test in artificial saliva, indicates an insignificant change of topography. This means that artificial saliva with pH 7.1 during the period of 21.5 days, do not induce observable corrosion of NiTi, by means of changes in surface roughness. This agrees with finding of Huan et al. [11], who found, that artificial saliva with pH value as high as 7.1 does not induce corrosion of Ni-Ti alloy.

An insignificant change of roughness and parameters, topography chemical composition, evaluated for areas of 80 x 80 µm, indicate that the medium employed for testing of Specimen 2 did not cause corrosion effects. However, the corrosion effects of the employed medium on specimen 2 are evident for the area of 10 x 10 μ m. We assume that this discrepancy is caused by large variations in roughness of specimen at areas of 80 x 80 μm. These variations act as a noise in signal and overlap the nano topographic changes caused by corrosion processes. Results for specimen 2 indicate that a medium with 0.05 % NaF (250 ppm fluoride) causes the corrosion effects of NiTi which are observable on a nano scale. This finding was also confirmed in previous investigation [2,6], with electrochemical tests, where is reported that similar concentration of fluoride in medium causes a decrease of corrosion resistance and induces corrosion effects on the surface.
